INDOOR AIR QUALITY ASSESSMENT

**Attleboro Fire Department, Briggs Corner Station
1276 Park Street
Attleboro, Massachusetts**

Prepared by:
Massachusetts Department of Public Health
Center for Environmental Health
Emergency Response/Indoor Air Quality Program
January 2006

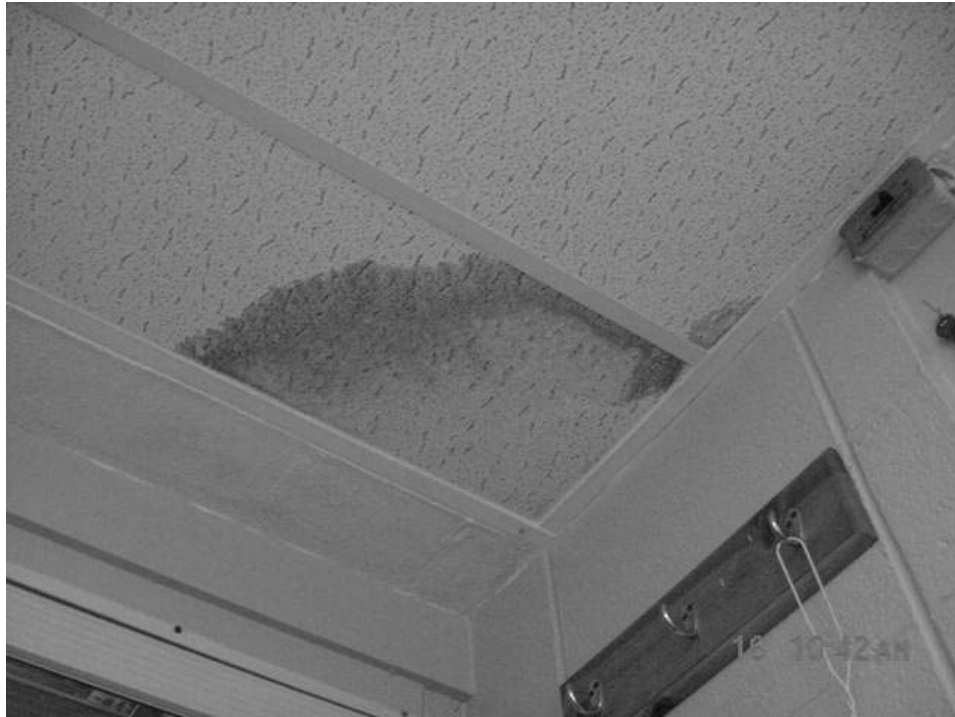
Picture 1

One area in the kitchen had water-damaged ceiling tiles (Picture 1). Water-damaged ceiling tiles can provide a source of mold and should be replaced after a moisture source or leak is discovered and repaired. MDPH staff removed the tiles to examine the ceiling plenum. The plenum was dry and no visible mold growth or associated odors were found at the time of the assessment. In addition, MDPH staff conducted moisture testing of water damaged ceiling tiles. All water damaged ceiling tiles tested were found to have low (i.e., normal) moisture content (Table 1) at the time of the assessment. MDPH staff also examined conditions directly outside the station in this area and observed loose flashing (Picture 2) that may serve as a source of water penetration under certain wind/weather conditions.

Water Damaged Ceiling Tiles in Corner of Kitchen near Exterior Door

1. Replace water damaged ceiling tiles. Monitor the kitchen and the bunkhouse areas for leaks and repair any water leaks as they may occur. Have flashing above this area at the kitchen/engine bay junction inspected for proper installation/function.
2. Replace kitchen door to engine bay. Ensure all doors accessing the engine bay are closed at all times.
3. Ensure doors around engine bay and mechanical room fit completely flush with threshold. Seal doors on all sides with foam tape, and/or weather-stripping.
Consider installing weather-stripping/door sweeps on both sides of doors with

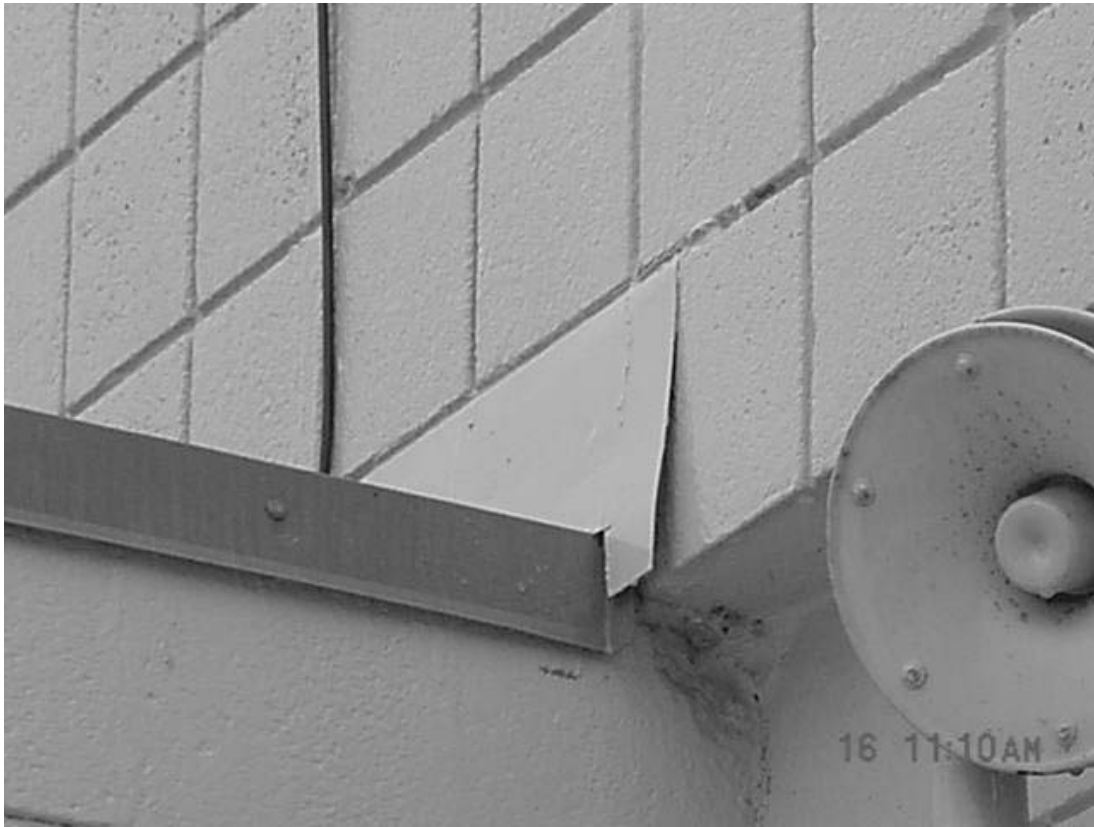
Picture 2

Loose Flashing between Station Roof and Engine Bay near Water Damaged Ceiling Tiles in Kitchen

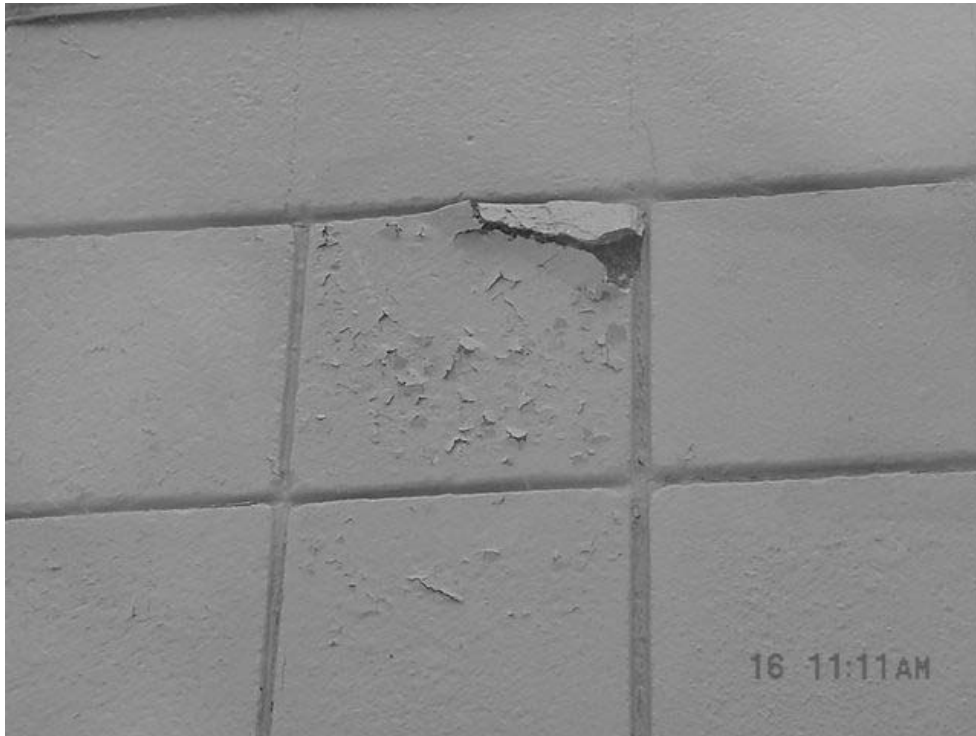
Picture 3

Another potential source for water penetration is through damaged exterior cinderblock (Picture 3), which were found in a few areas. Over time, freezing and thawing can undermine the integrity of the building envelope and provide a means of water entry into the building through concrete and masonry.

Damaged Exterior Block

9. Seal/repair damaged masonry on the exterior of the building to prevent water penetration, drafts and pest entry.
 10. Consider cleaning carpeting annually or semi-annually in soiled high traffic areas as per the recommendations of the Institute of Inspection, Cleaning and Restoration Certification (IICRC). Copies of the IICRC fact sheet can be downloaded at: http://www.cleancareseminars.com/carpet_cleaning_faq4.htm (IICRC, 2005)

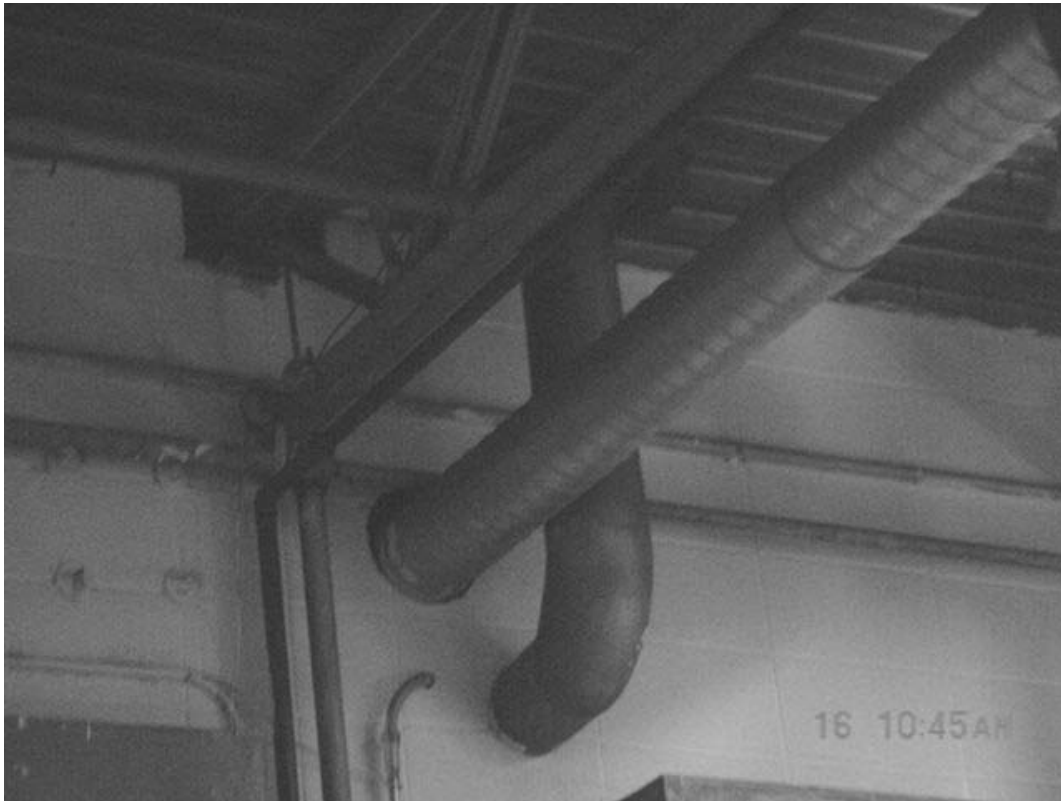
Picture 4

The local exhaust system for the engine bay consists of a series of ducted exhaust vents running across the ceiling of the engine bay. These ducted vents are connected to a large exhaust motor on the exterior wall of the engine bay and cuff directly onto the tailpipe of fire engines (Pictures 4 and 5). Although the engine bay is equipped with a mechanical ventilation system, a number of pathways for vehicle exhaust and other pollutants to move from the engine bay into occupied areas were identified.

Exhaust Terminus outside the Building for the Local Exhaust Ventilation System

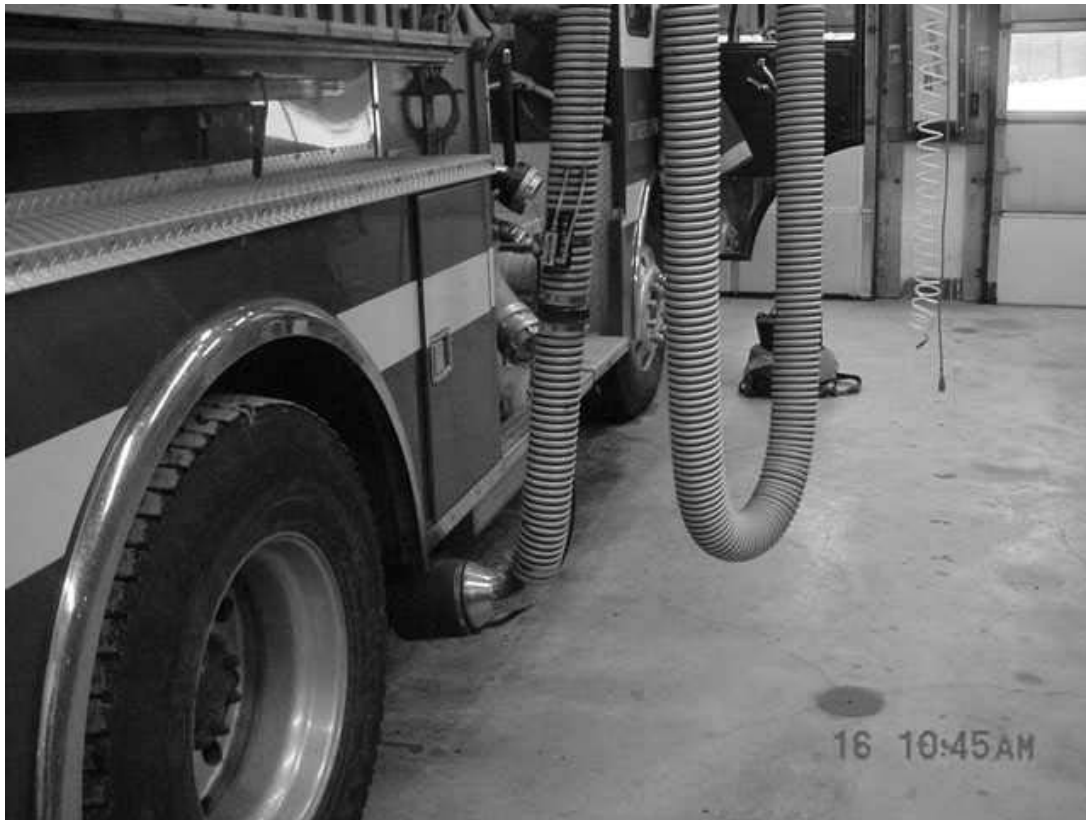
Picture 5

Pressurized Cuff on Tailpipe for Local Exhaust System

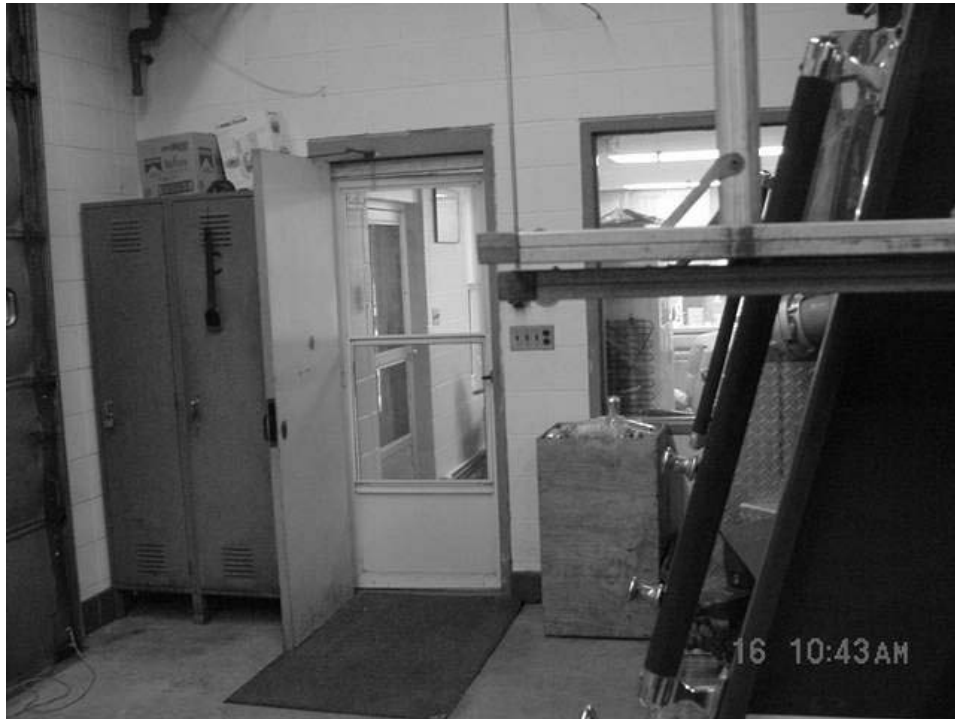
Picture 6

The kitchen door to the engine bay is typically propped open (Picture 6), allowing diesel exhaust and associated particulates to move from the engine bay into occupied areas of the station. In addition, the doorknob to the kitchen was removed, leaving a hole through the door (Picture 7). The mechanical room and bunkhouse doors had spaces beneath/around them from which light could be seen penetrating; these spaces can serve as pathways for diesel exhaust and

Kitchen Door to Engine Bay Propped Open

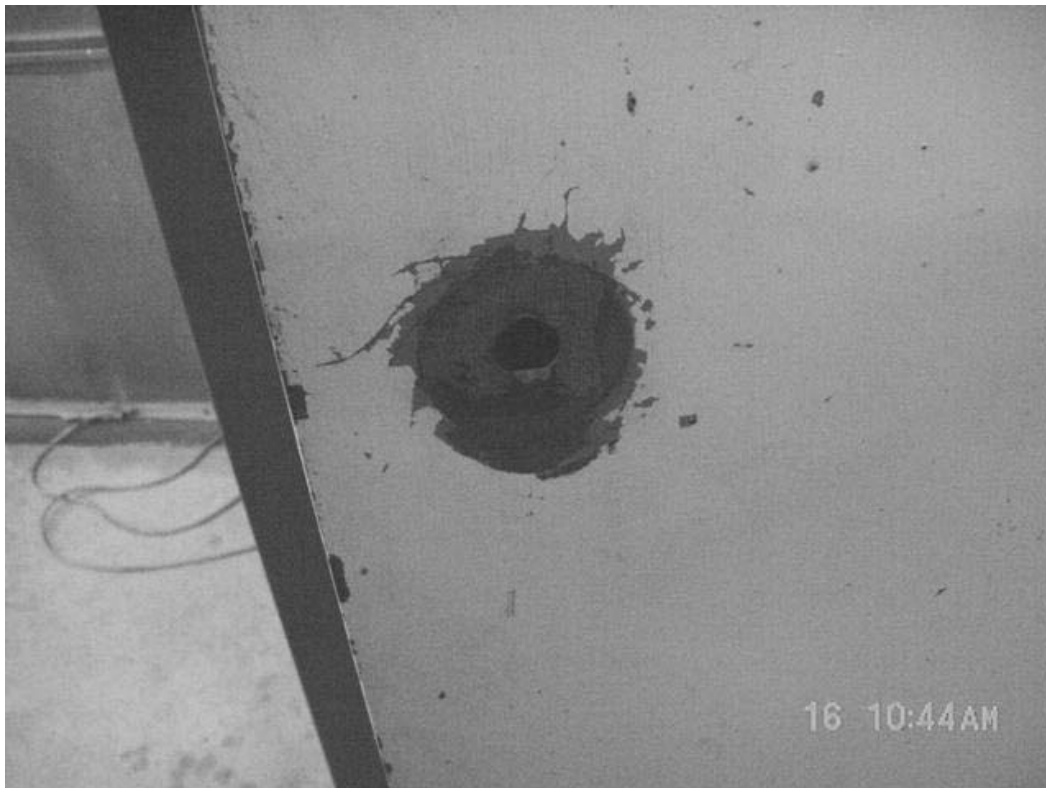
Picture 7

Hole in Engine Bay/Kitchen Door Where Doorknob was Removed

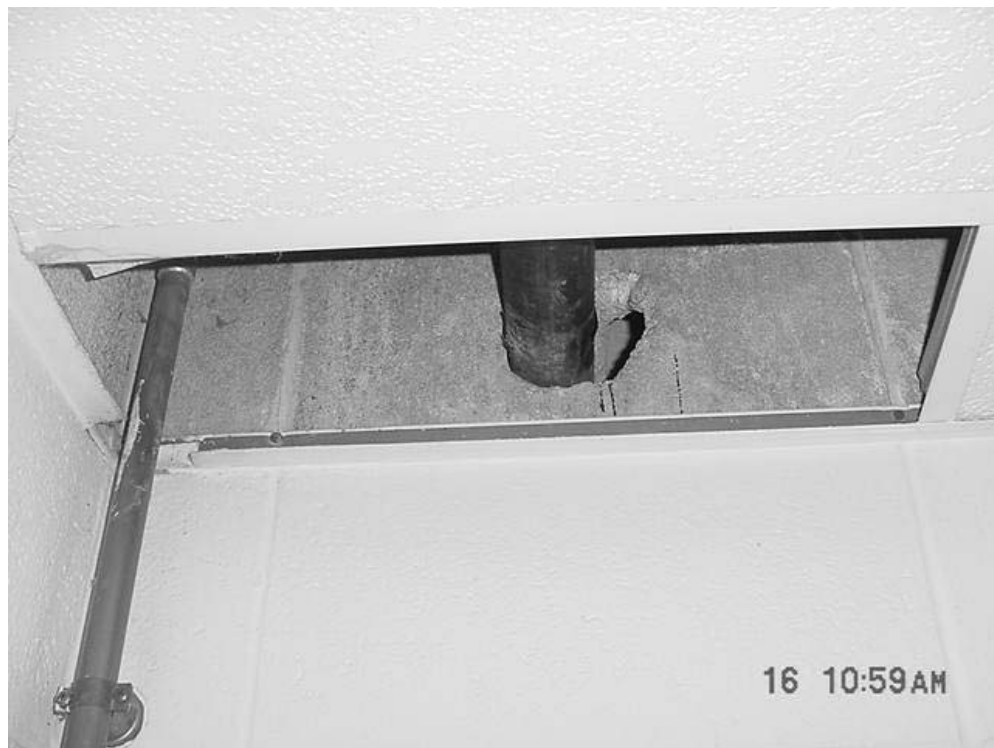
Picture 8

Another possible pathway for exhaust emissions is through utility holes. The ceiling/walls of the engine bays (and mechanical room) are penetrated by holes for utilities (Pictures 8 and 9). If they are not airtight, these holes can present potential pathways into occupied areas.

Utility Hole in Common Wall between Bunkhouse and Engine Bay

- access to the engine bay to provide a dual barrier. Ensure tightness of doors by monitoring for light penetration and drafts around doorframes.
4. Ensure all utility holes are properly sealed in the engine bay and mechanical room and at their terminus to eliminate pollutant paths of migration.

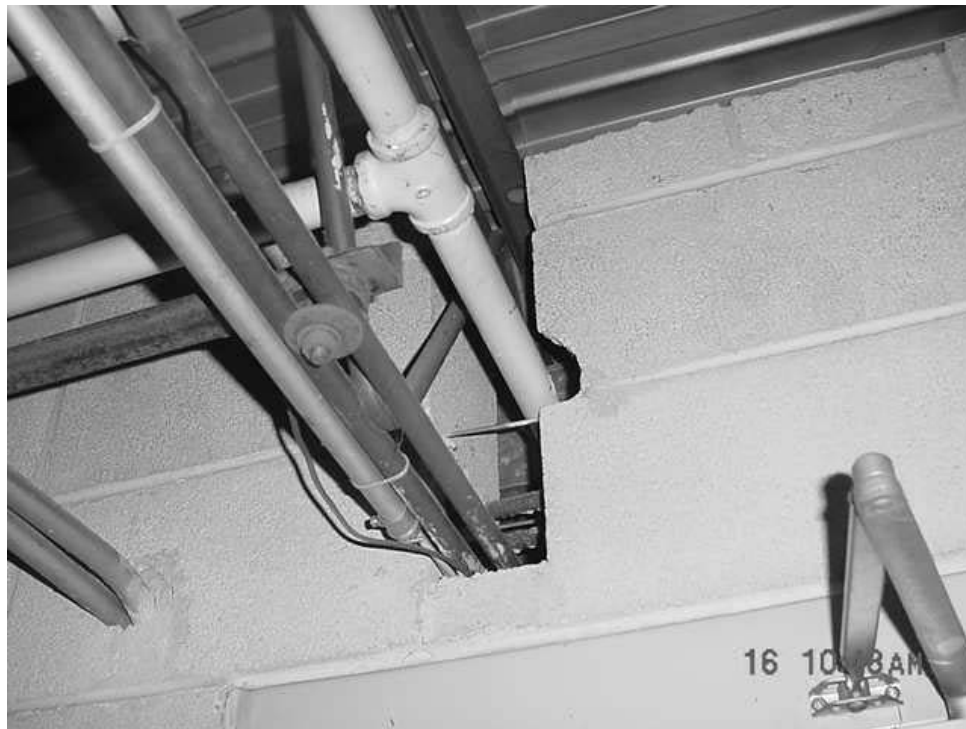
Picture 9

Utility Hole for Pipes in Mechanical Room

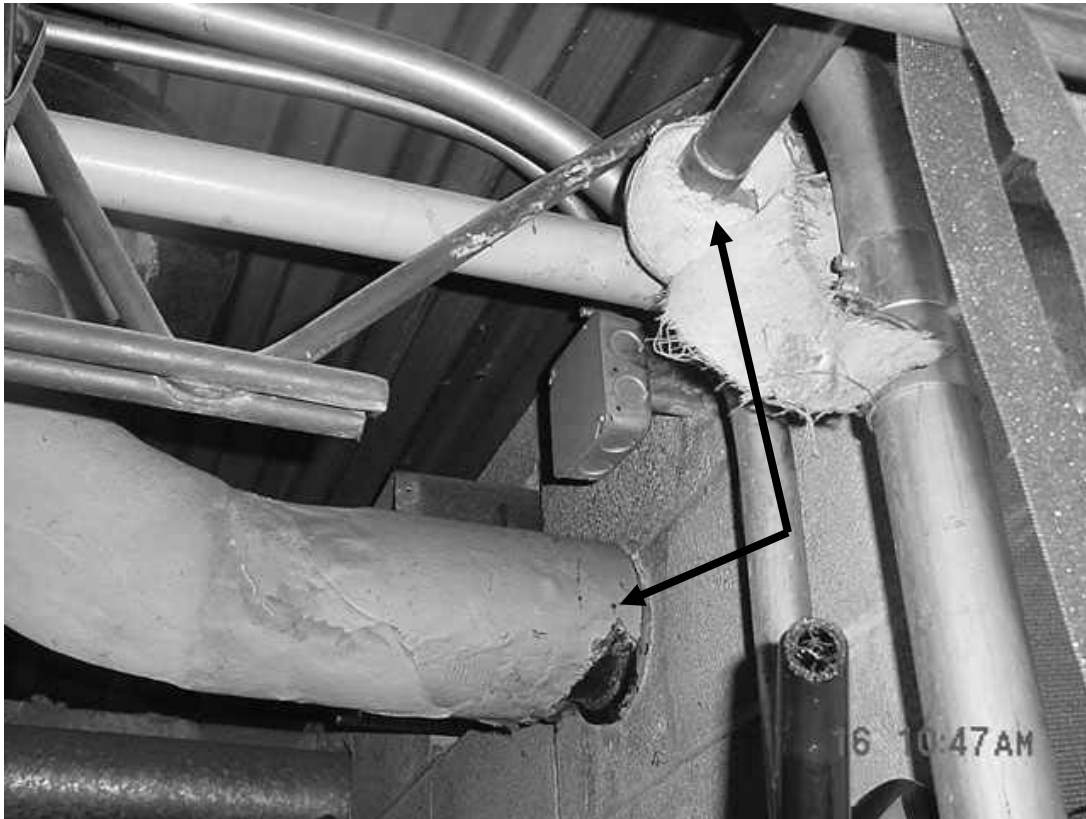
Picture 10

Exposed insulation material was observed on two pipes in the mechanical room (Picture 10). The pipe insulation most likely is an asbestos containing material. Prior to leaving the station, MDPH staff contacted Deputy Fire Chief Erik Guillette and recommended that the insulation be re-wrapped by a licensed asbestos remediator as soon as practicable.

Exposed Insulation Material in Mechanical Room

8. Remove or remediate damaged pipe insulation in mechanical room in conformance with Massachusetts asbestos remediation and hazardous waste disposal laws.

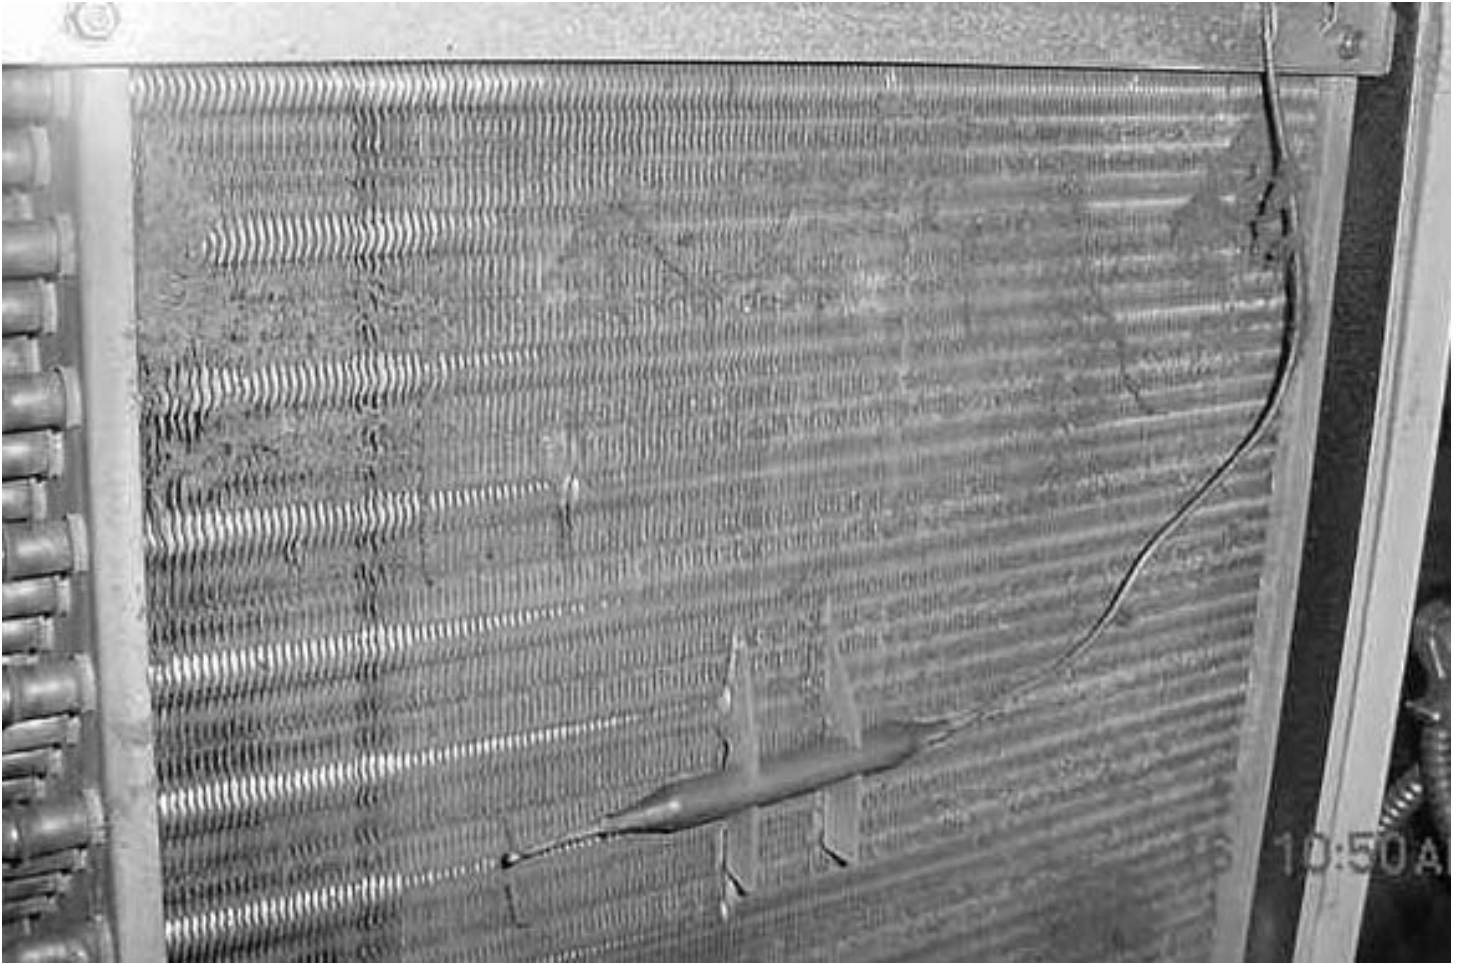
Picture 11

Finally, window-mounted air conditioners (AC) are reportedly used to provide cooling during spring/summer months. MDPH staff inspected these AC units and found the cooling coils had accumulated dust and debris (Picture 11). The addition of moisture to the accumulated debris in the cooling coils can provide conditions for mold growth, which can be aerosolized when the AC units are activated.

Accumulated Dust and Debris in Cooling Coils of AC Unit

5. Clean/change filters for AC units as per the manufacturer's instructions or more frequently if needed. Clean cooling coils of dust and debris prior to activation.
